## Property Inspection Report

Property address: **4205 Marina #11**

**Carlsbad, Ca 92009**

Inspection date: **Wednesday, August 12, 2009**

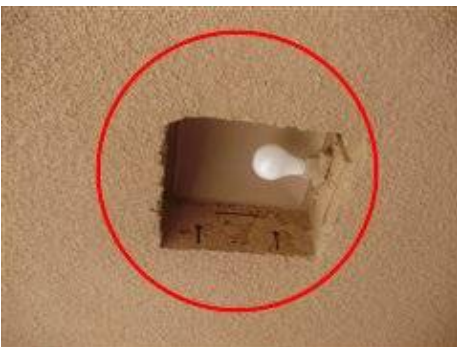
Photo 5

There is a missing lens cover for the light on the Deck. A qualified contractor or electrician should evaluate and make repairs as necessary so light fixtures are securely mounted and installed in accordance with the manufacturer's installation instructions.

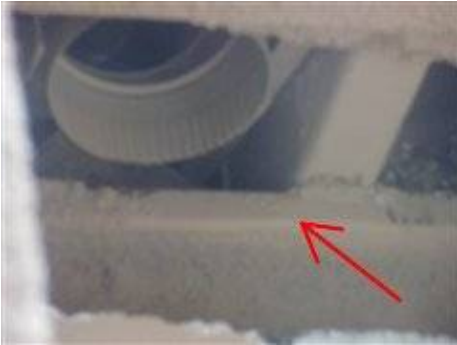
Photo 15

Outside of the Deck around West side an opening is exposed and a Bird has made a Nest. This could facilitate Mites that to come into the Condo. Contact Condo HOA and have them repair.

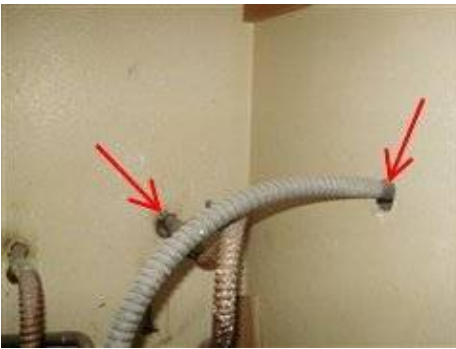
Photo 4

Gaps around pipes that feed Water Heater. Insect infestation could occur.

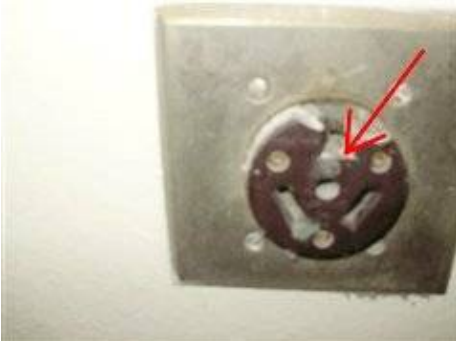
Photo 12

The ground on the 220 outlet is defective. Have a Licensed Electrician repair or replace.

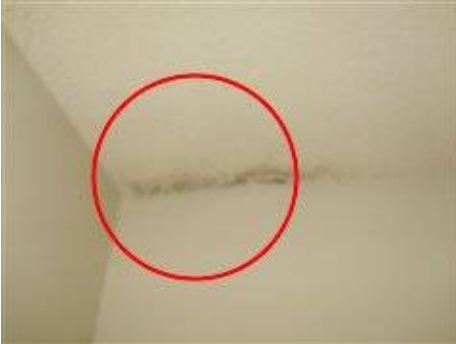
Photo 7

Water stain in upper left hand corner of Washer/Dryer closet. Unknown age or source. Contact a Licensed Plumber to evaluate.

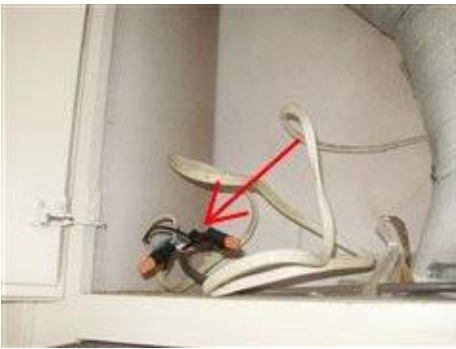
Photo 1

Electrical wires are exposed above the Microwave and should be contained within an Electrical box and secured to the wall or Cabinet.

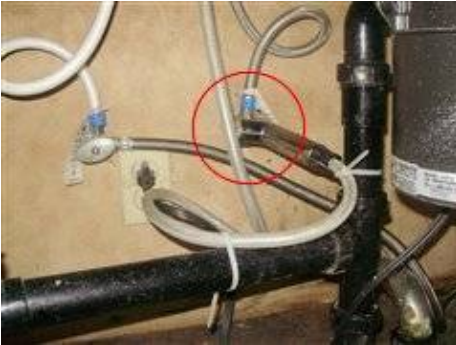
Photo 3

24) 🔧 The sink sprayer at the kitchen sink is inoperable or defective. It should be replaced, and by a qualified plumber if necessary.

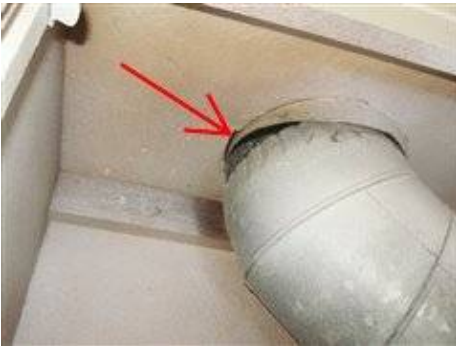
Photo 2

25) 🔧 Vent above the Microwave has become detached from main vent pipe.

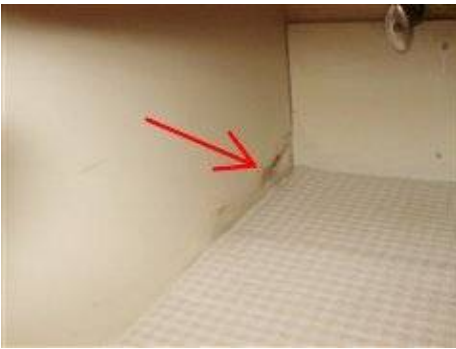
Photo 8

28) ⓘ Water stains and/or minor water damage was found in the shelving or cabinet components below the sink. The client(s) should evaluate and consider having repairs made.

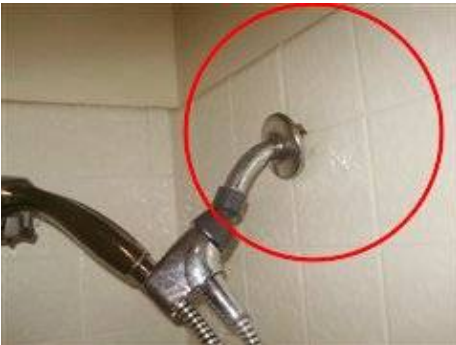
Photo 11

Shower Head is loose from the wall. Have a Licensed Plumber inspect it for repair. It also leaks from several places.

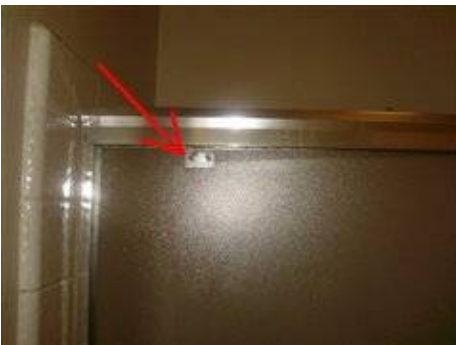
Photo 16

Glass sliding door in Tub/Shower area is broken.

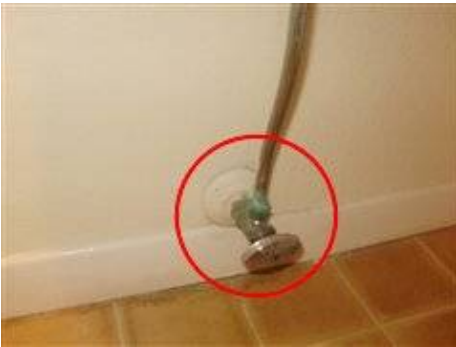
Photo 10

The shutoff Valve to the Toilet seems to have had a leak. No water present at the time of inspection.

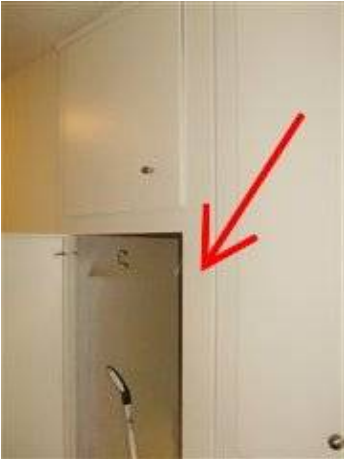
Photo 13

46) 🛠️ The water closet Cabinet frame is loose.

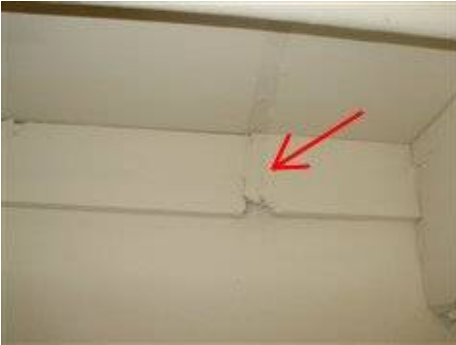
Photo 6

47) 🛠️ Crack in Shelving in Bedroom.

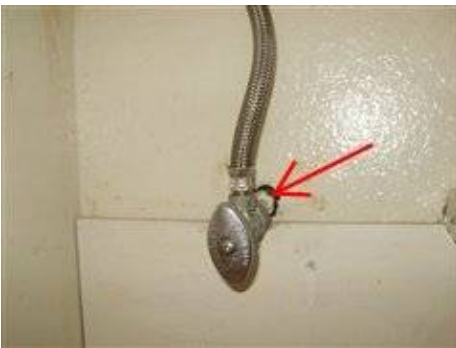
Photo 9  
Gaps around undersink Shutoff  
Valve in Bathroom.
